Aerobic Biological In-situ Remediation

Martin Slooijer

16th of July 2013

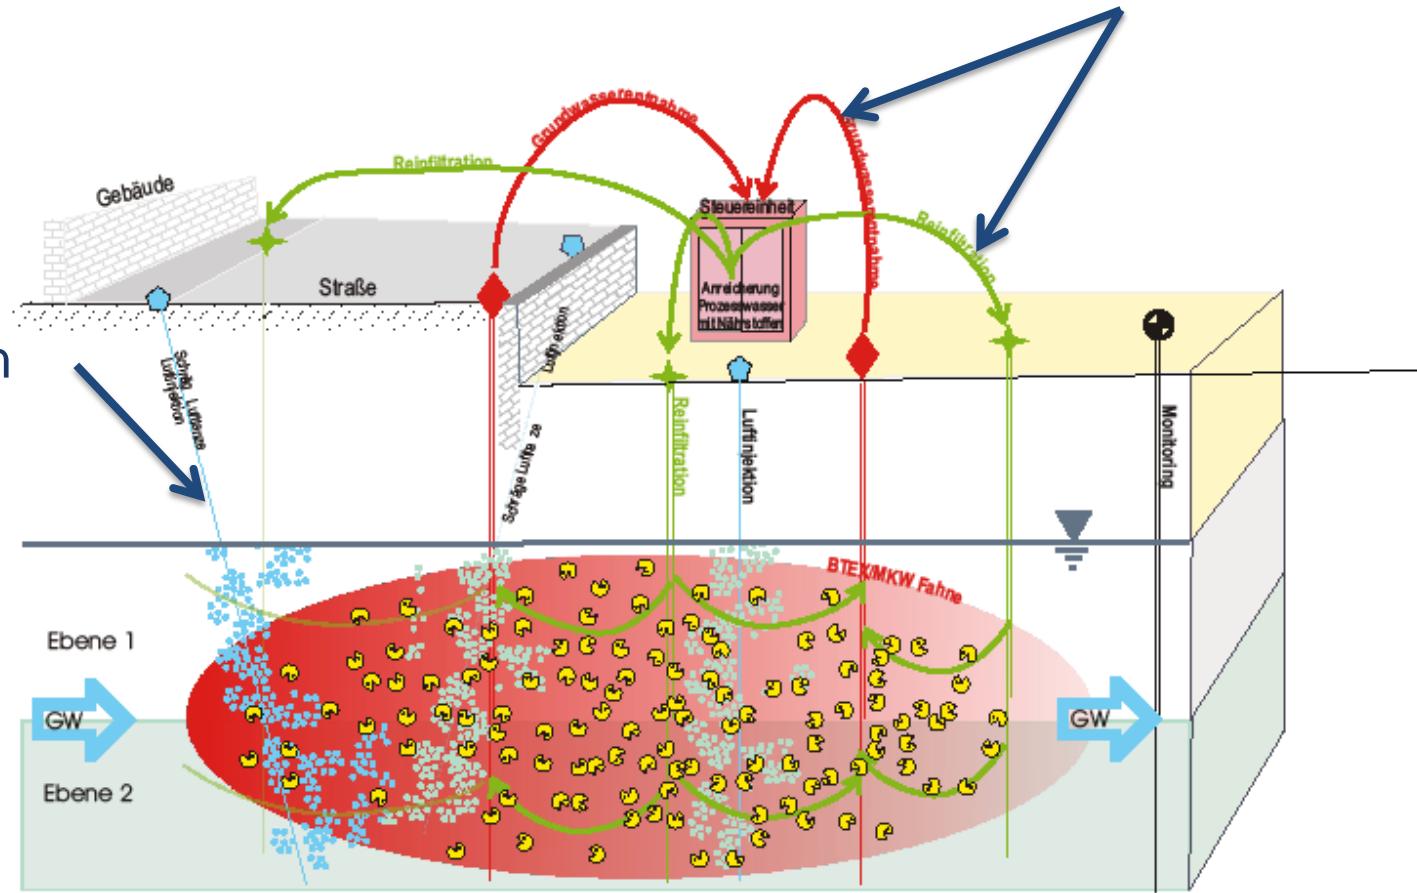
Aerobic Remediation

Groundwater circulation for distribution of nutriënts

Air injection for supply of oxygen

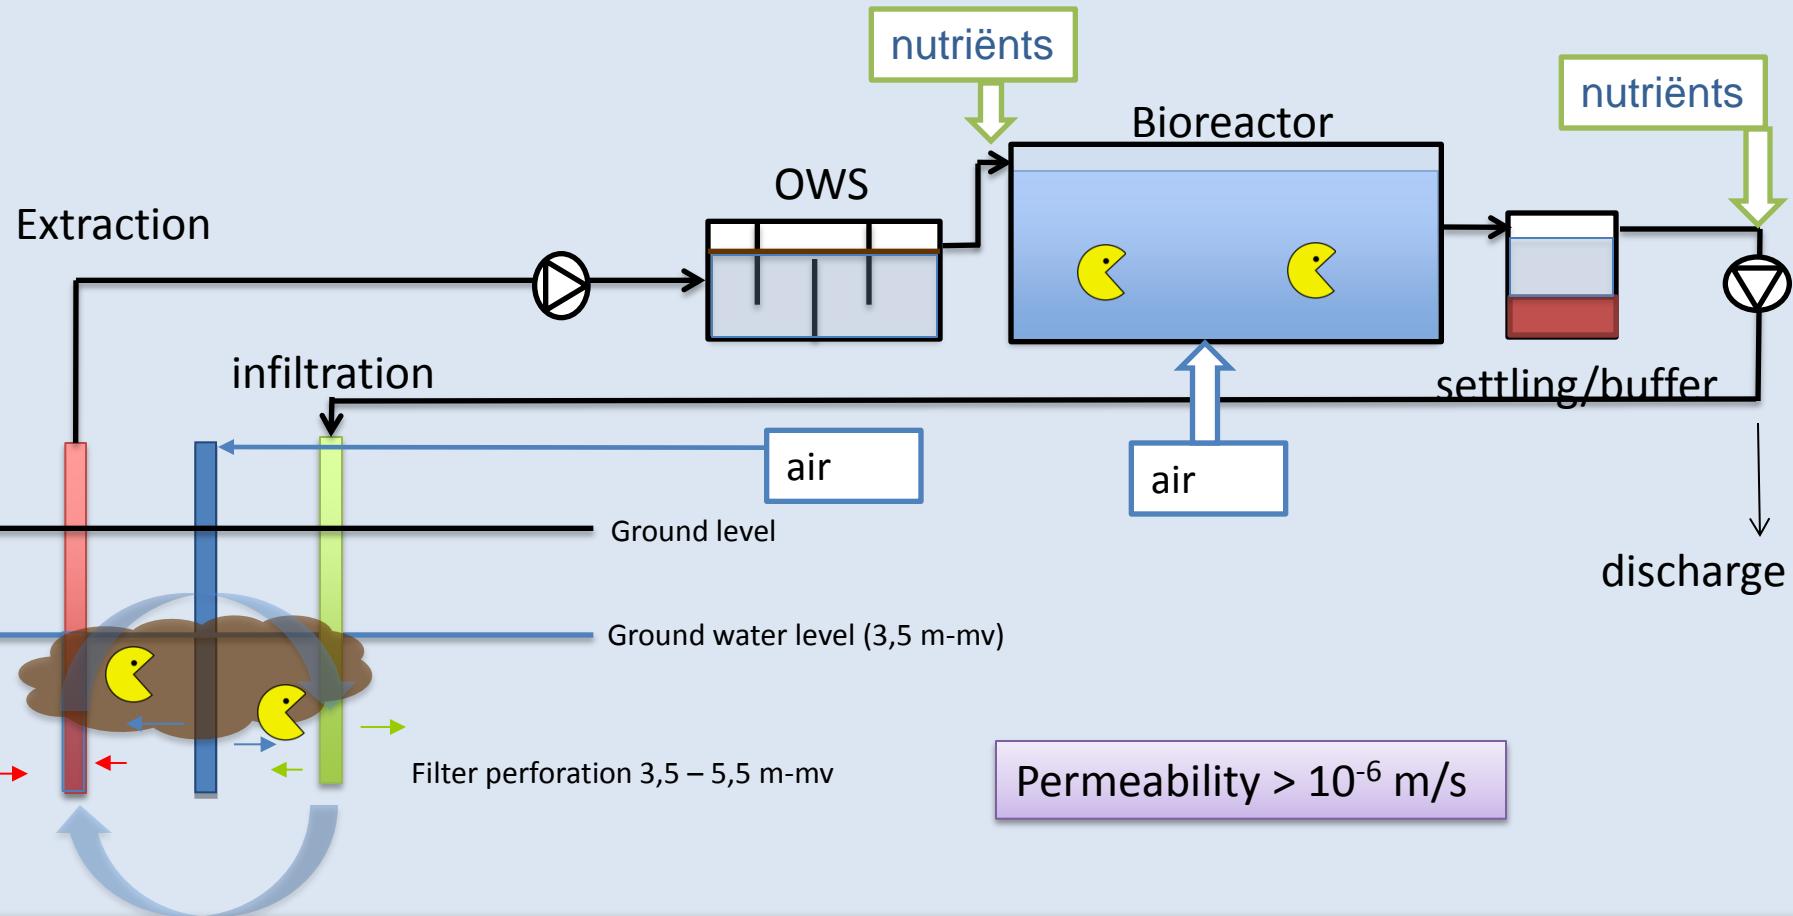
In-situ remediation

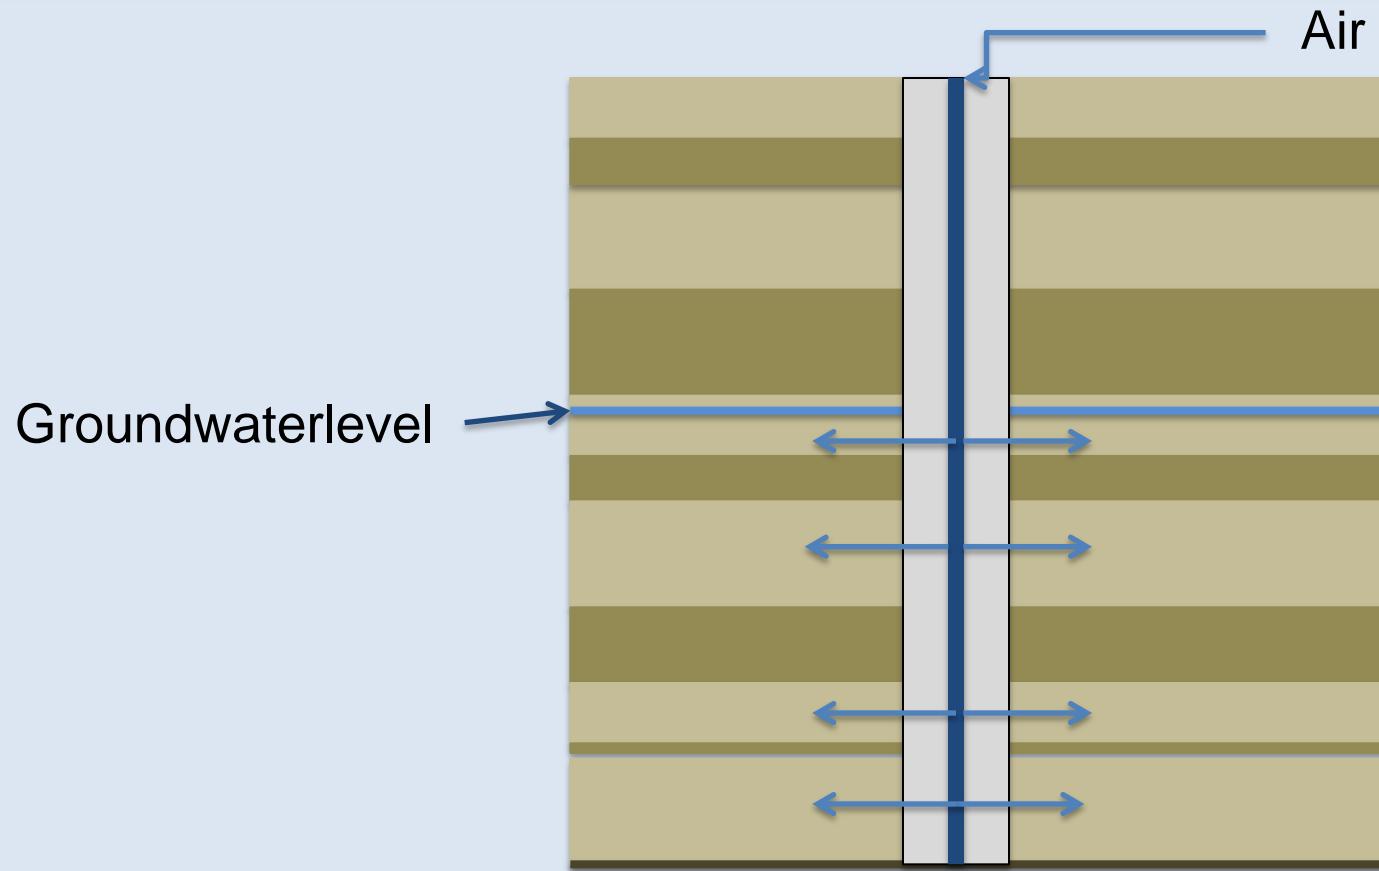
Remediation approach

Remediation approach

The unsaturated zone: ***Soil Vapour Extraction:***

- SVE filters 3-9,5 m-gl
- Biofilters for cleaning of Vapour

The saturated zone: ***Enhanced Biological Degradation***

- Extraction wells 16 m-gl
- Water treatment : bioreactors
- Infiltration wells 16 m-gl
- Airsparging lances 16 m-gl

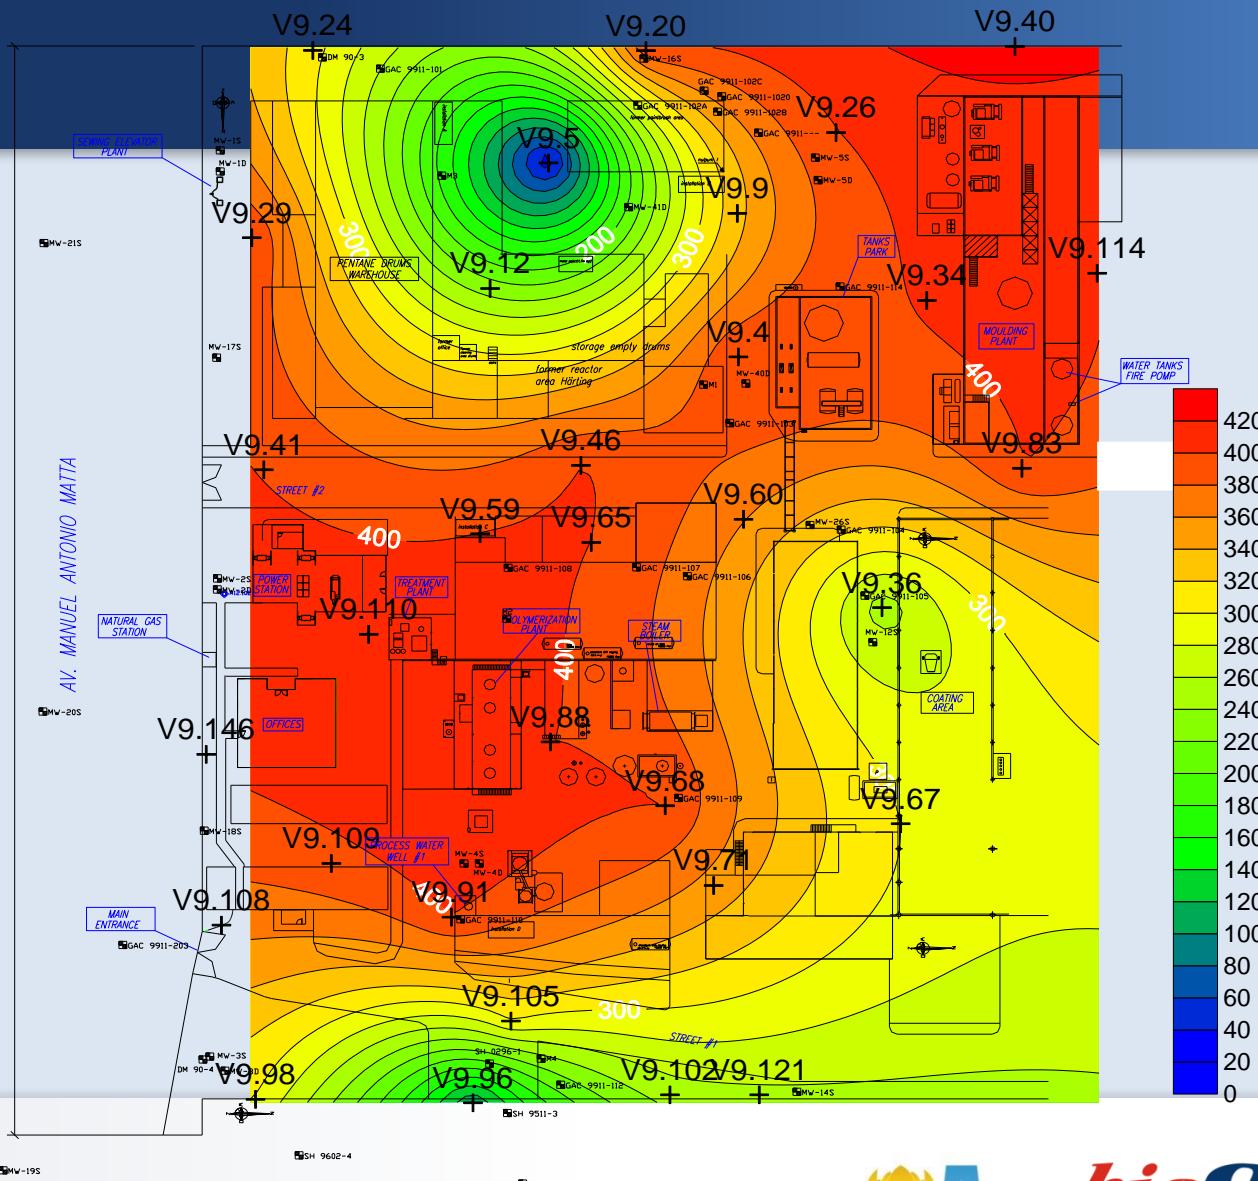
Vapor extraction - Xylene - (ppm) (August 2004)

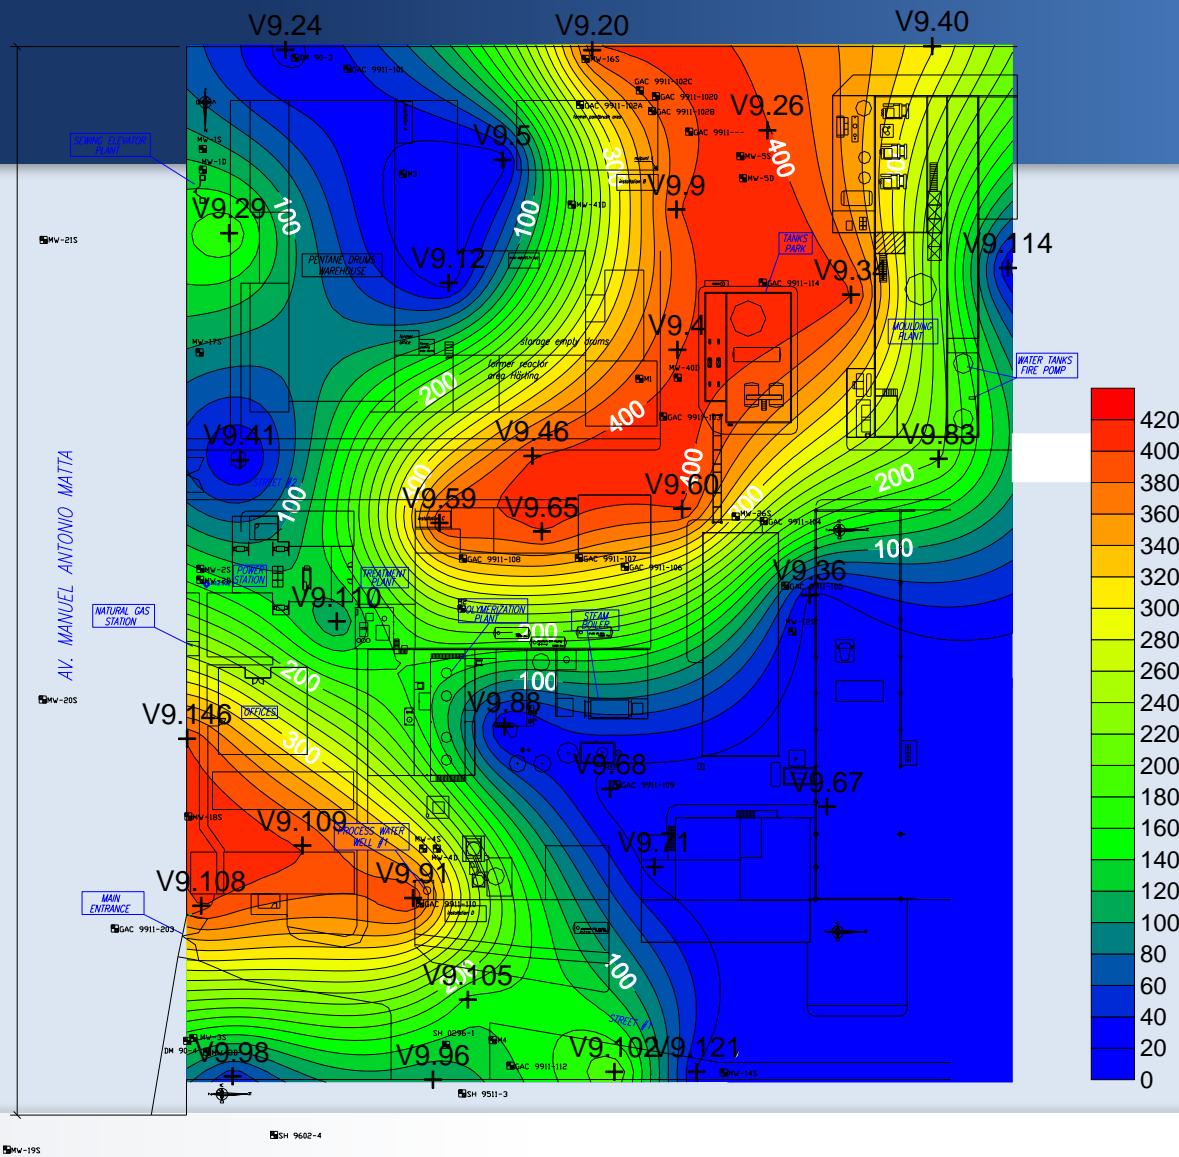
Vapor extraction - Xylene - (ppm) (March 2005)

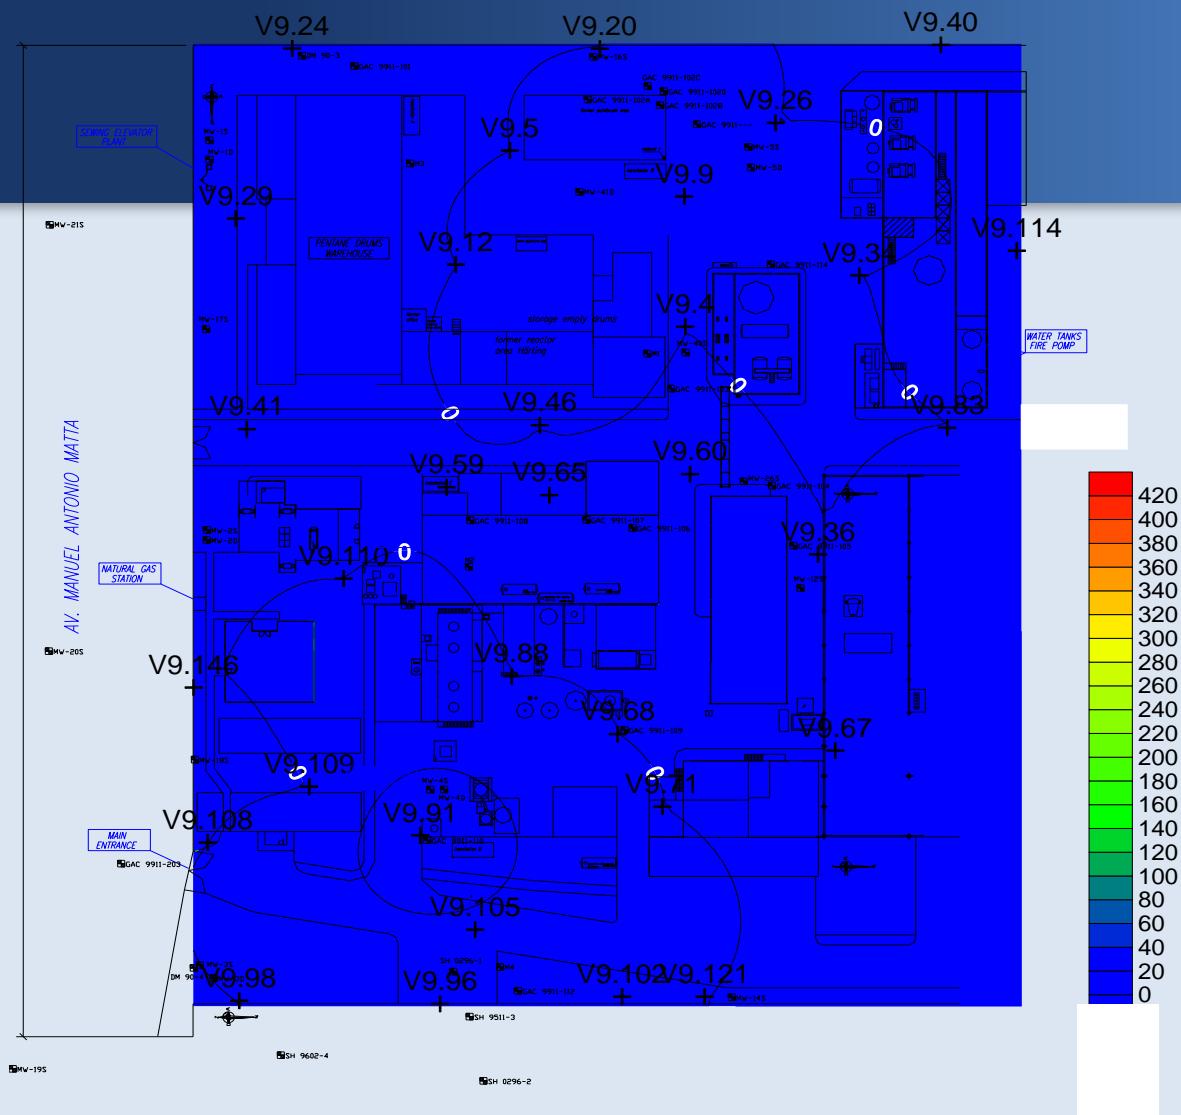
Vapor extraction - Xylene - (ppm) (March 2006)

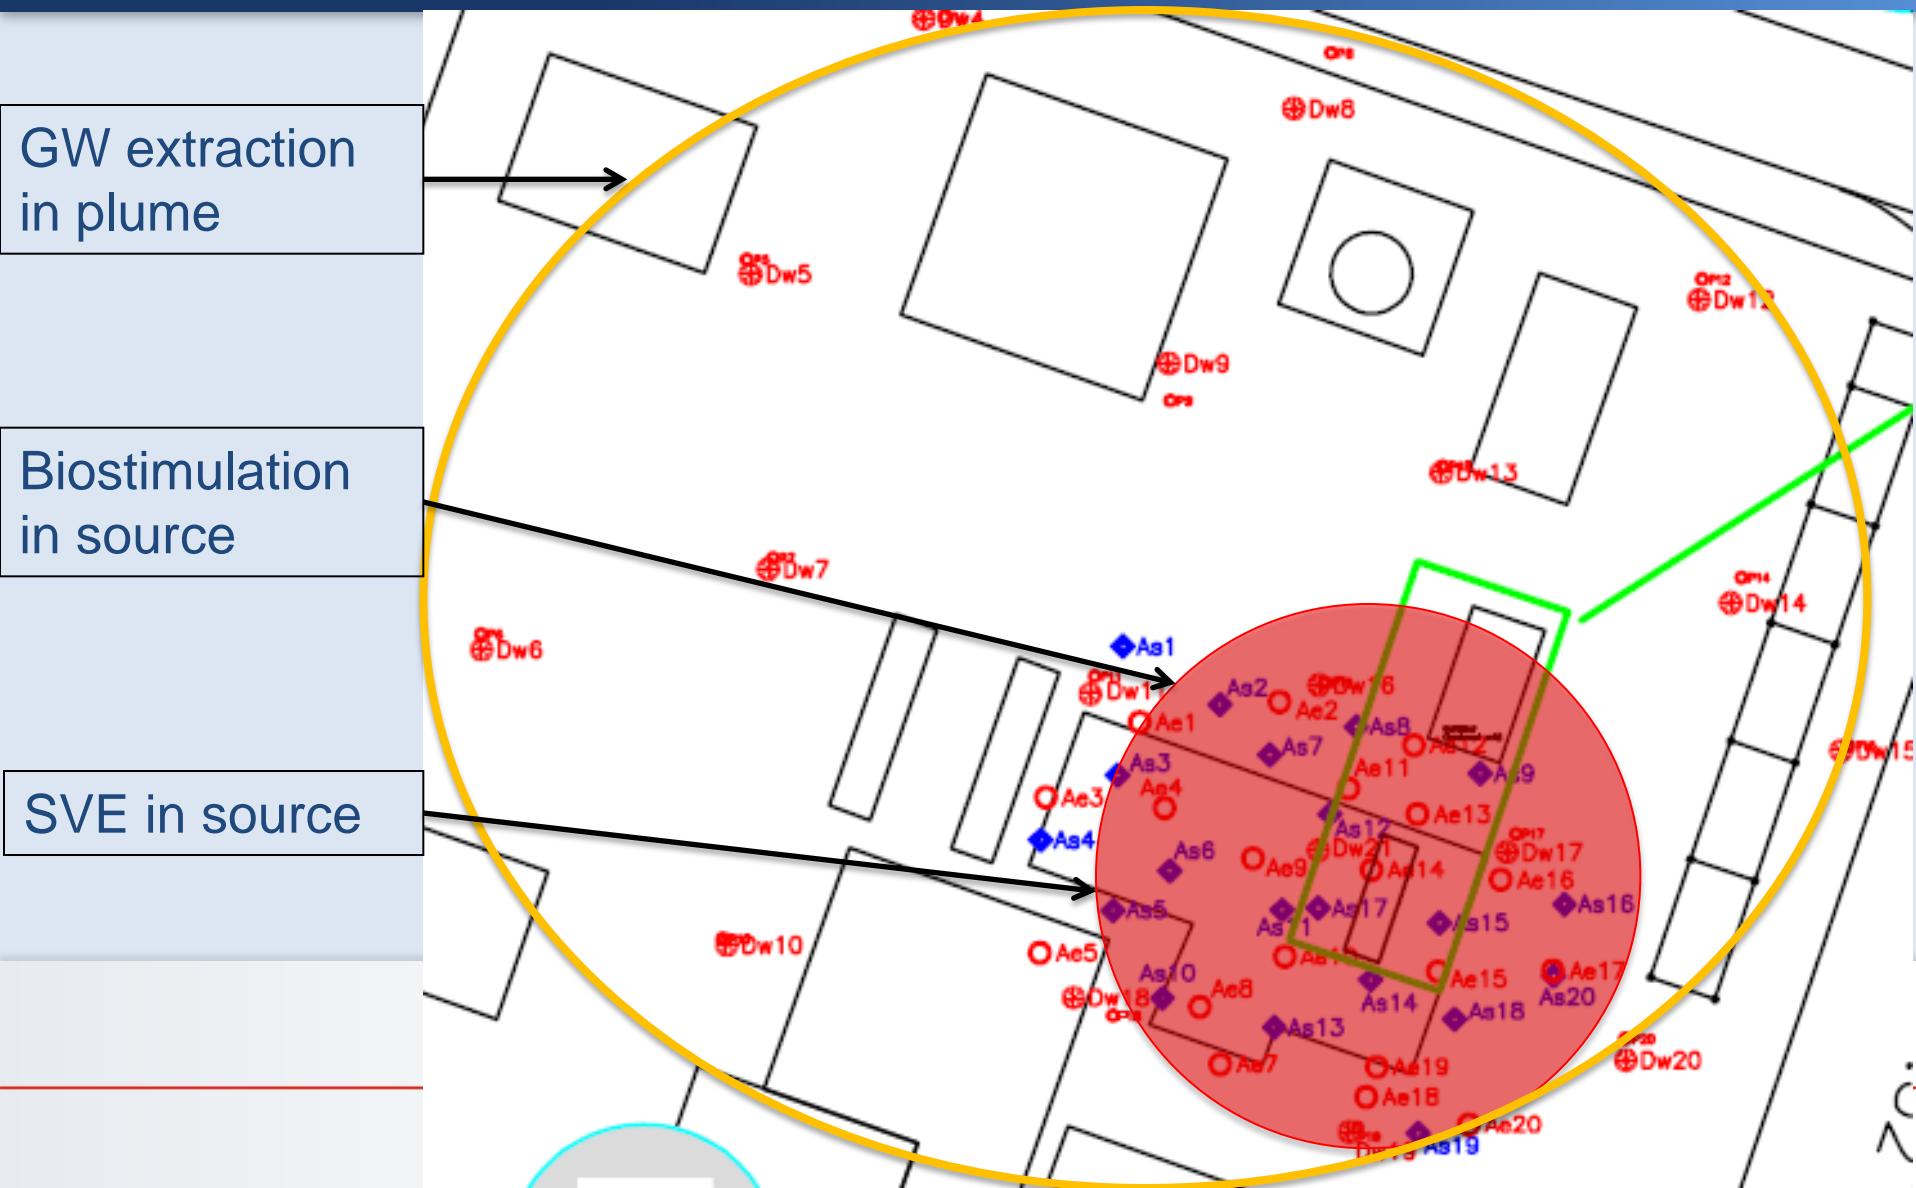
Remediation Design

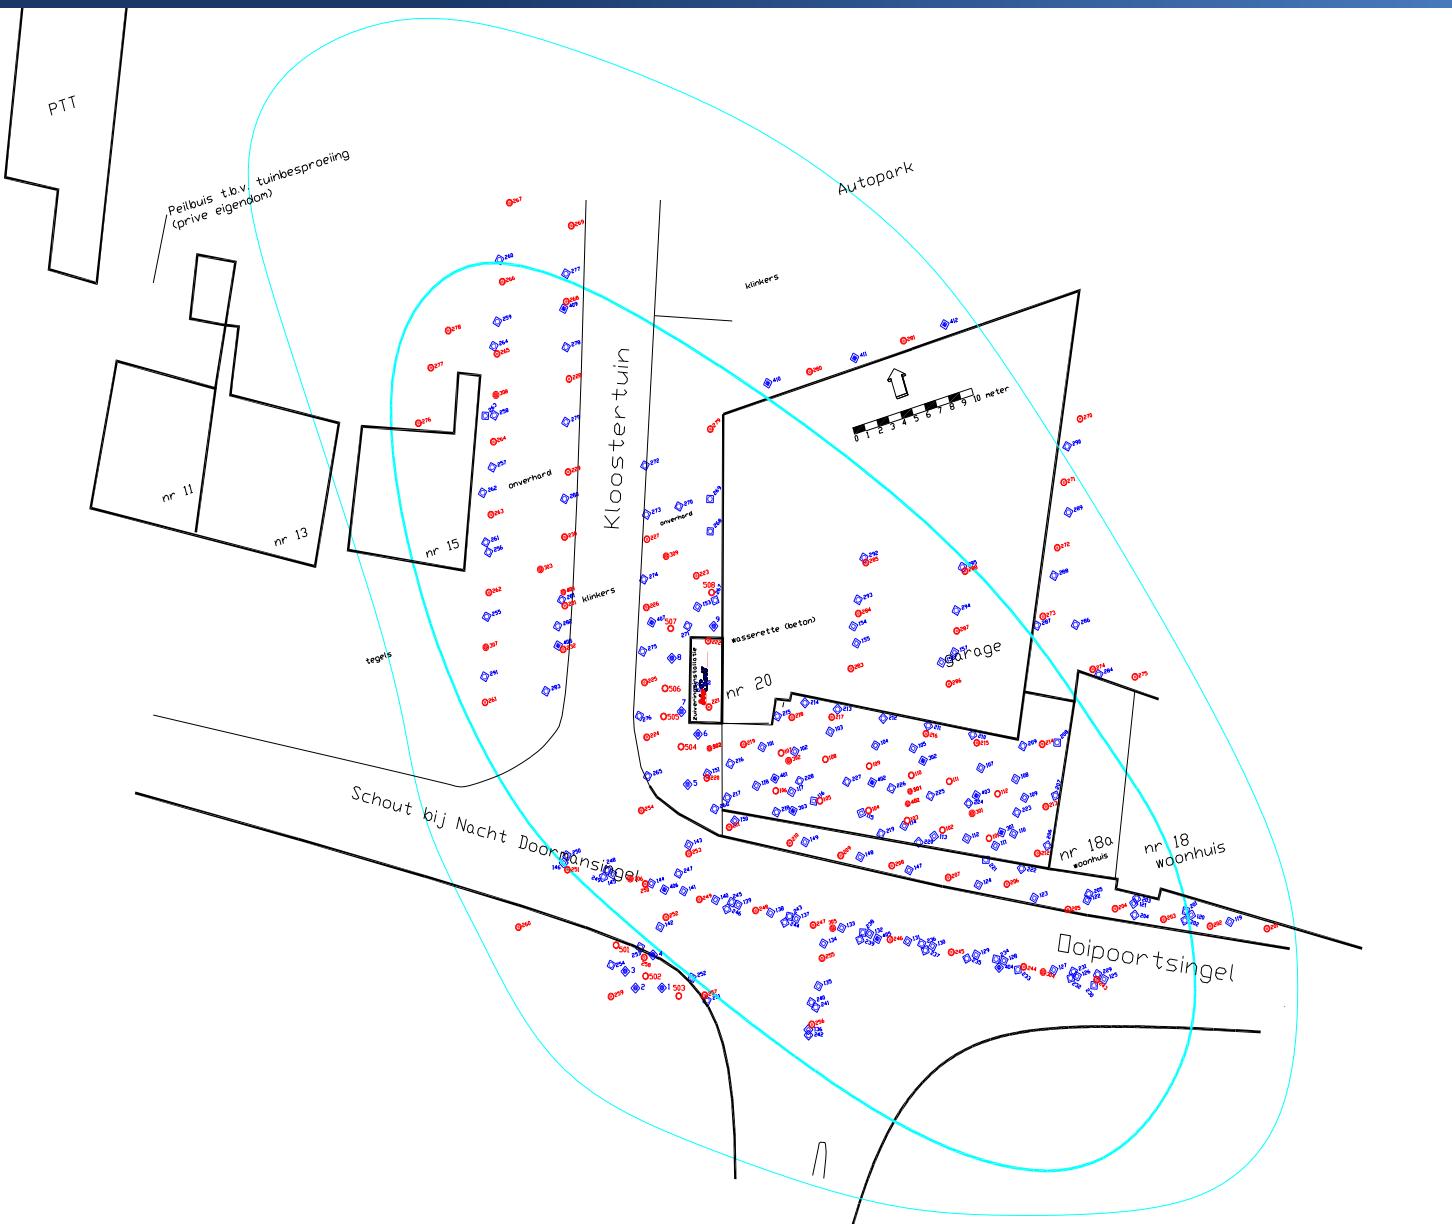
Remediation design

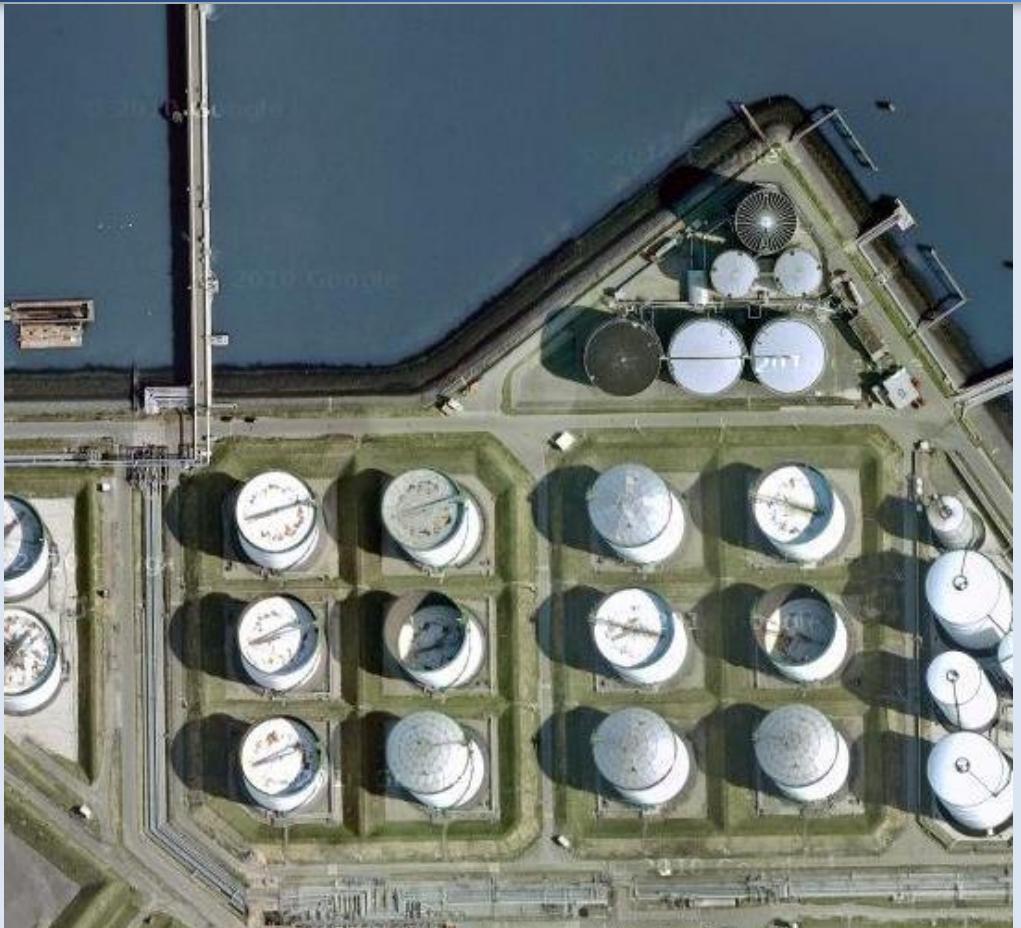
Aerobic Bioscreen

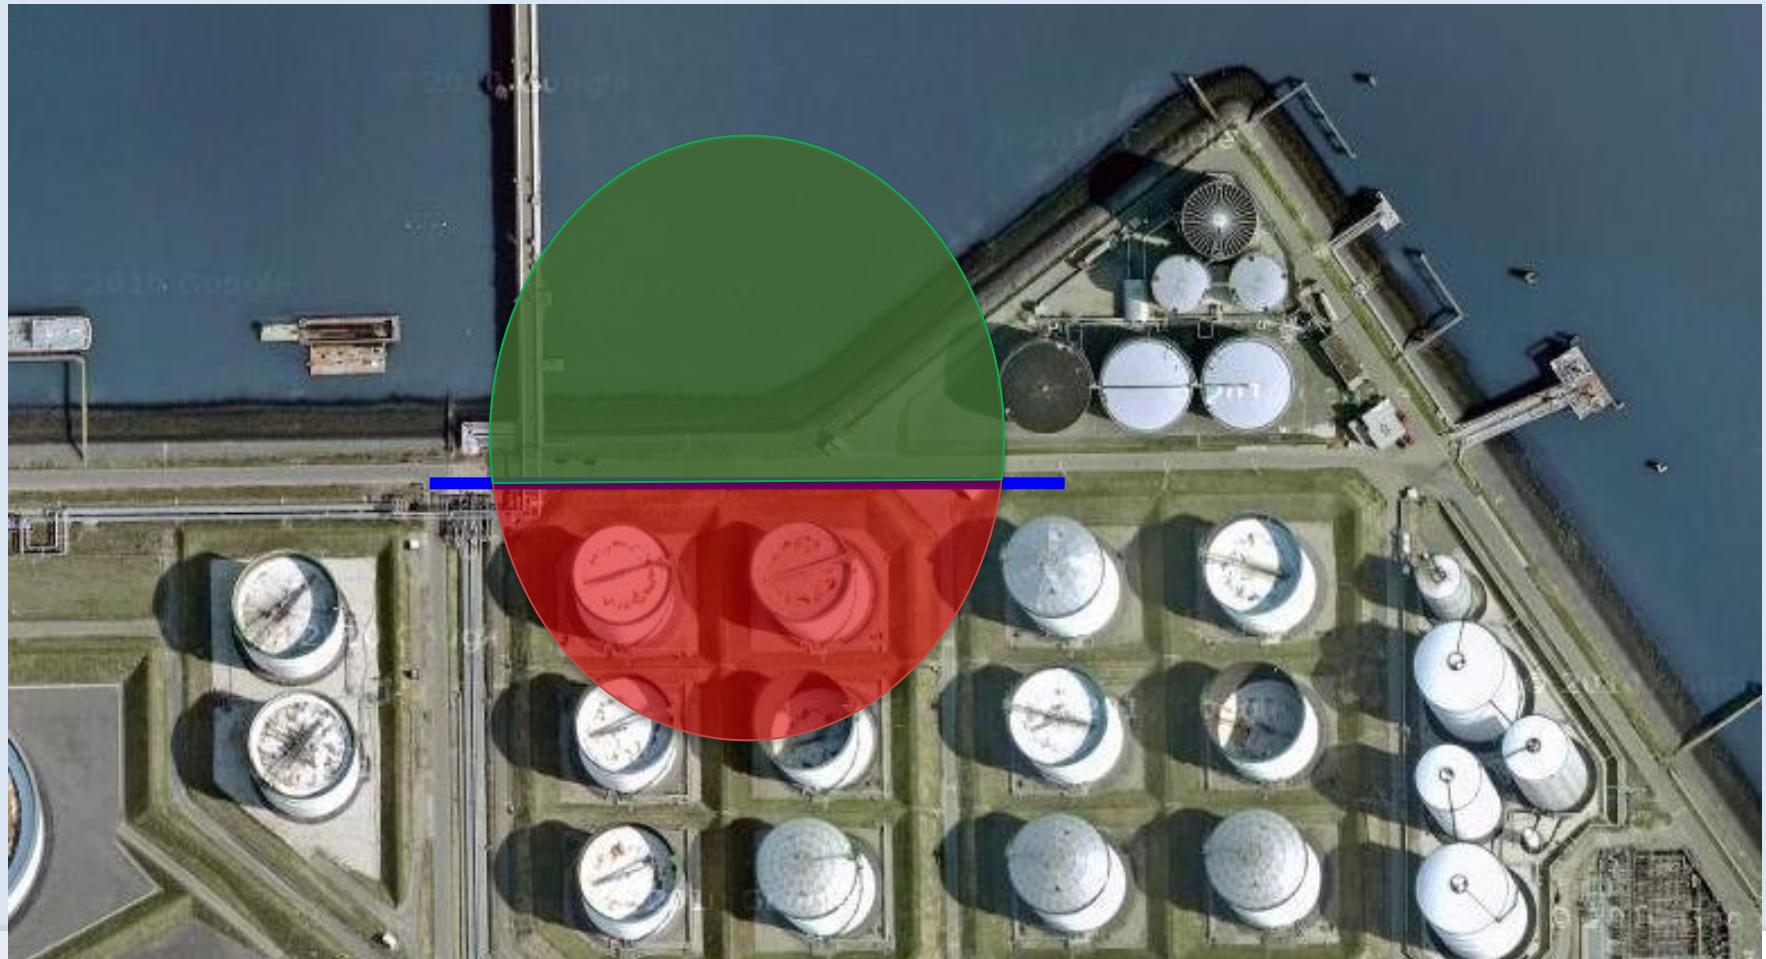
Location bioscreen and contamination

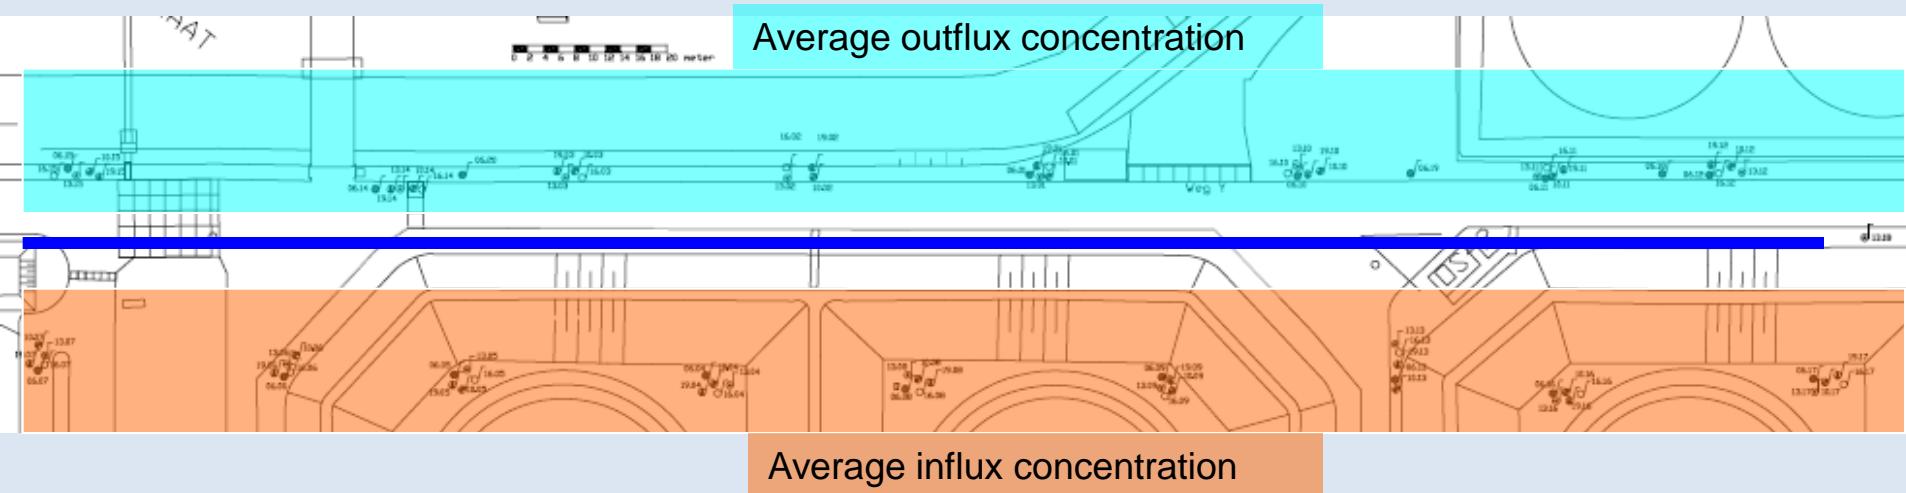
Monitoring effectiveness of the screen

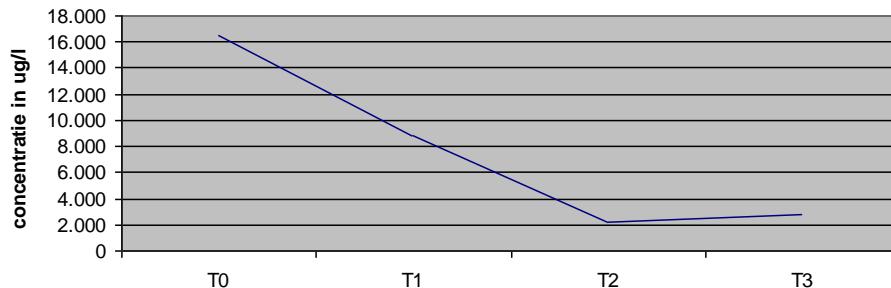
Concentration decrease behind the bioscreen

Gem. outflux olie C6-40+BTEXN Laag 1 (tot 6 m-mv)

T0 = januari 2009

T1 = augustus 2009

T2 = december 2009

T3 = april 2010

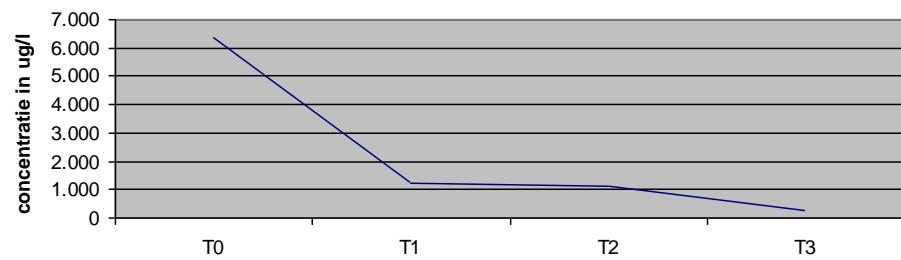
Gem. outflux olie C6-40+BTEXN Laag 2 (tot 10 m-mv)

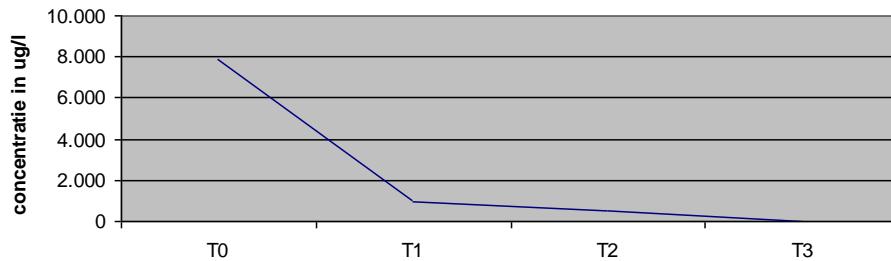
Gem. outflux olie C6-40+BTEXN Laag 3 (tot 13 m-mv)

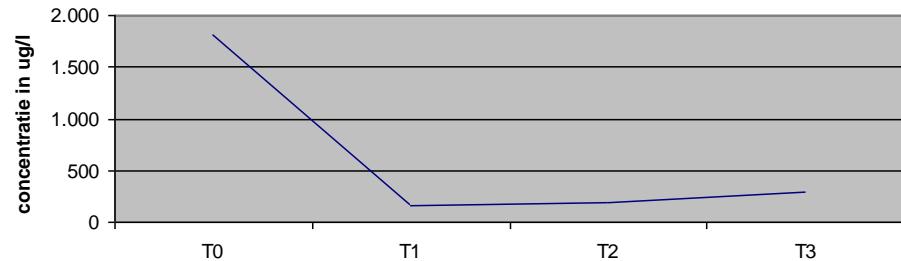
Gem. outflux olie C6-40+BTEXN Laag 4 (tot 16 m-mv)

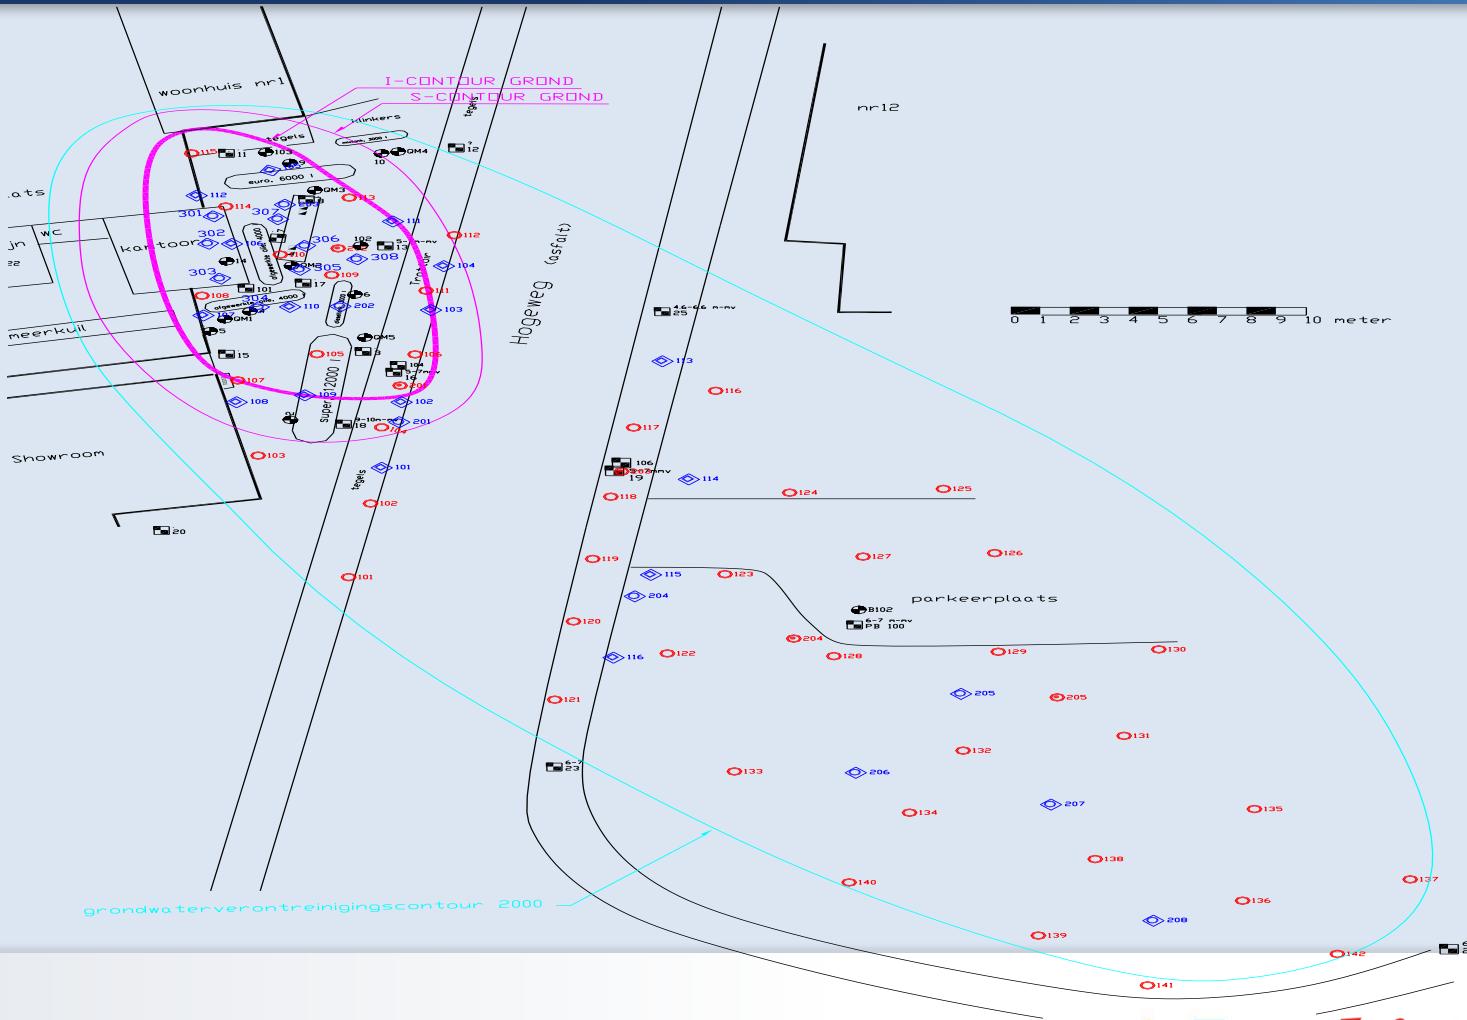
Remediation Design
